ECHO BAY AIRPORT

Pavement Condition

2007 PCI Inpsection

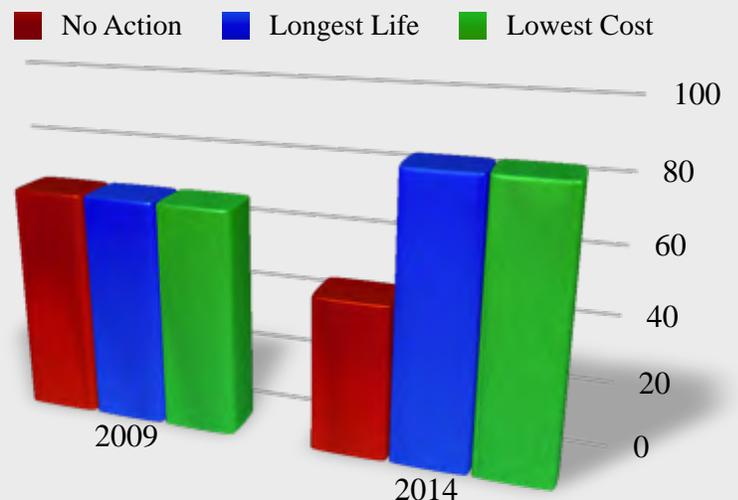
The following graph shows the projected pavement condition. If no action is taken, the average PCI is projected to fall from **68** to **46** by **2013**. The longest life and lowest annual cost repair strategies are the same, and both are projected to cost approximately **\$292,000**.

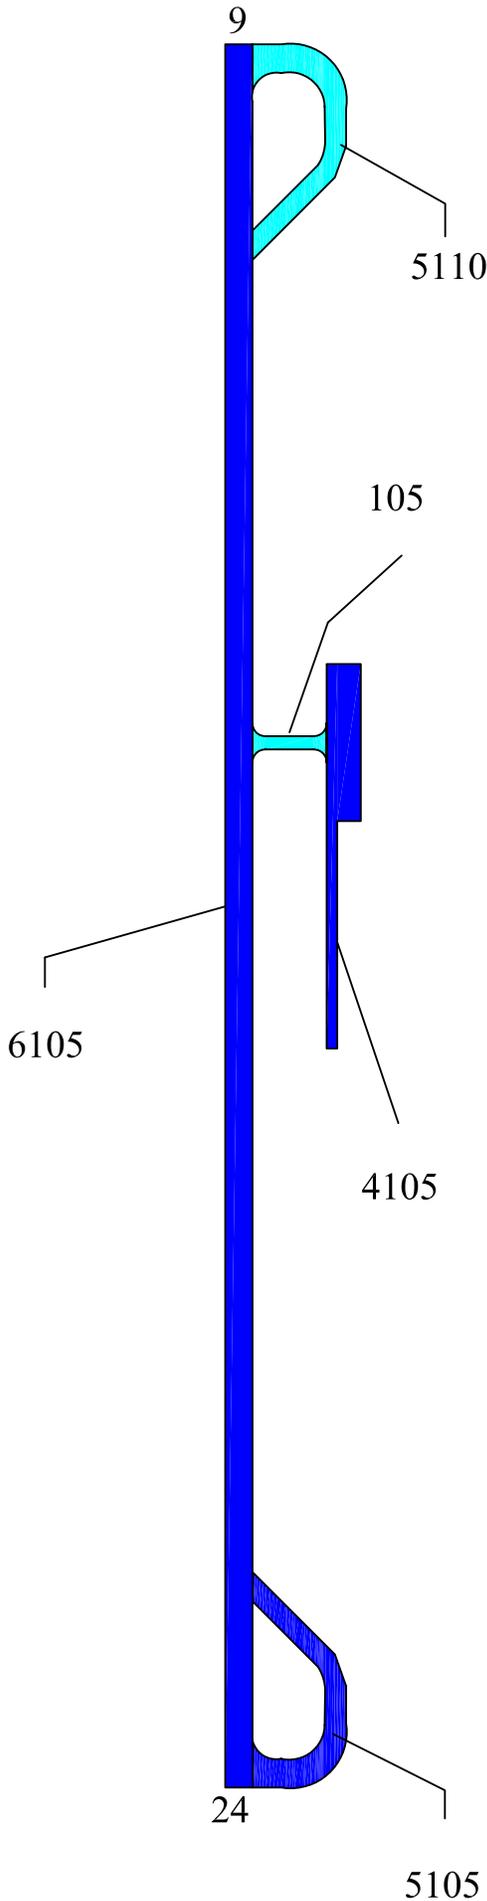
FEATURE	PCI	TYPE	AGE	DET. RATE
105	63	AC	6	6.2
4105	75	AC	6	4.2
5105	71	AC/AC	6	4.8
5110	68	AC/AC	6	5.3
6105	72	AC/AC	6	4.7

FEATURE	ACTION YR	ACTION	COST (\$)	LIFE EXT
105	2009	Structural Overlay	10,367	17
4105	2014	Resurfacing	36,659	17
5105	2011	Crack Repair	3,878	1
5105	2011	Resurfacing	26,729	17
5110	2010	Crack Repair	5,497	1
5110	2010	Resurfacing	30,023	17
6105	2010	Resurfacing	225,243	15
6105	2010	Crack Repair	30,769	1
