WELLS / HARIET FIELD

HARIET FIELD 2008 PCI Inspection

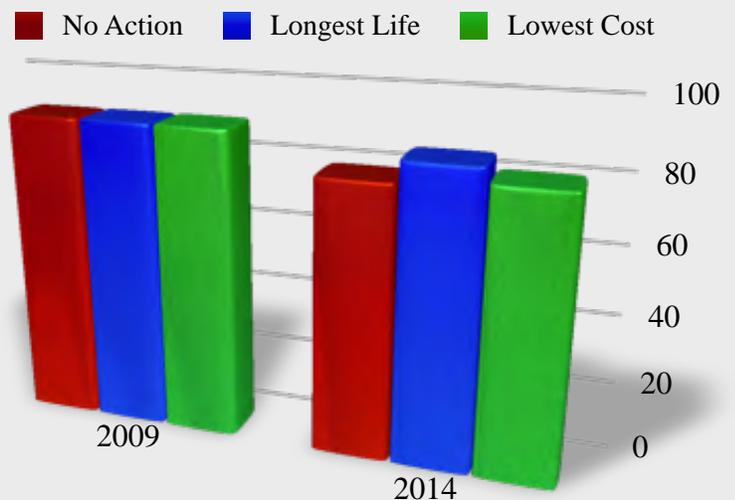
The following graph show the projected pavement condition. If no action is taken, the average PCI is projected to fall from **89** to **79** by **2014**. Selecting the longest life repair strategy is projected to cost approximately **\$91,000**. The lowest annual cost repairs are projected to cost **\$25,000**.
