ELY AIRPORT

ELY AIRPORT
2008 PCI Inspection

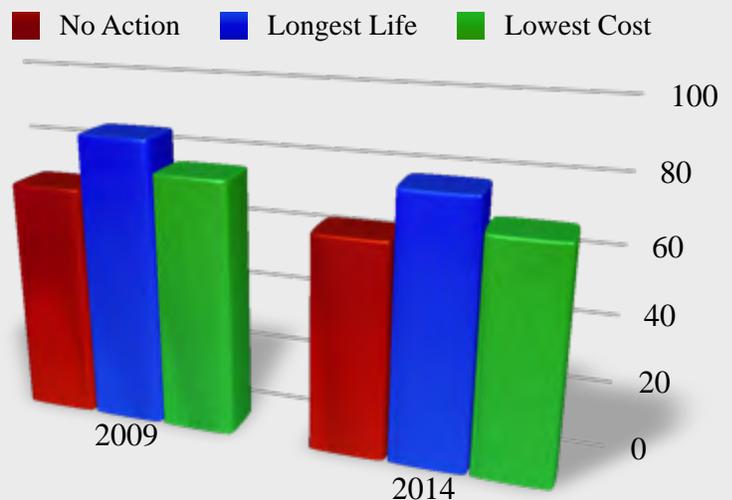
The following graph show the projected pavement condition. If no action is taken, the average PCI is projected to fall from **69** to **64** by **2014**. Selecting the longest life repair strategy is projected to cost approximately **\$1.5 million**. The lowest annual cost repairs are projected to cost approximately **\$1.1 million**.

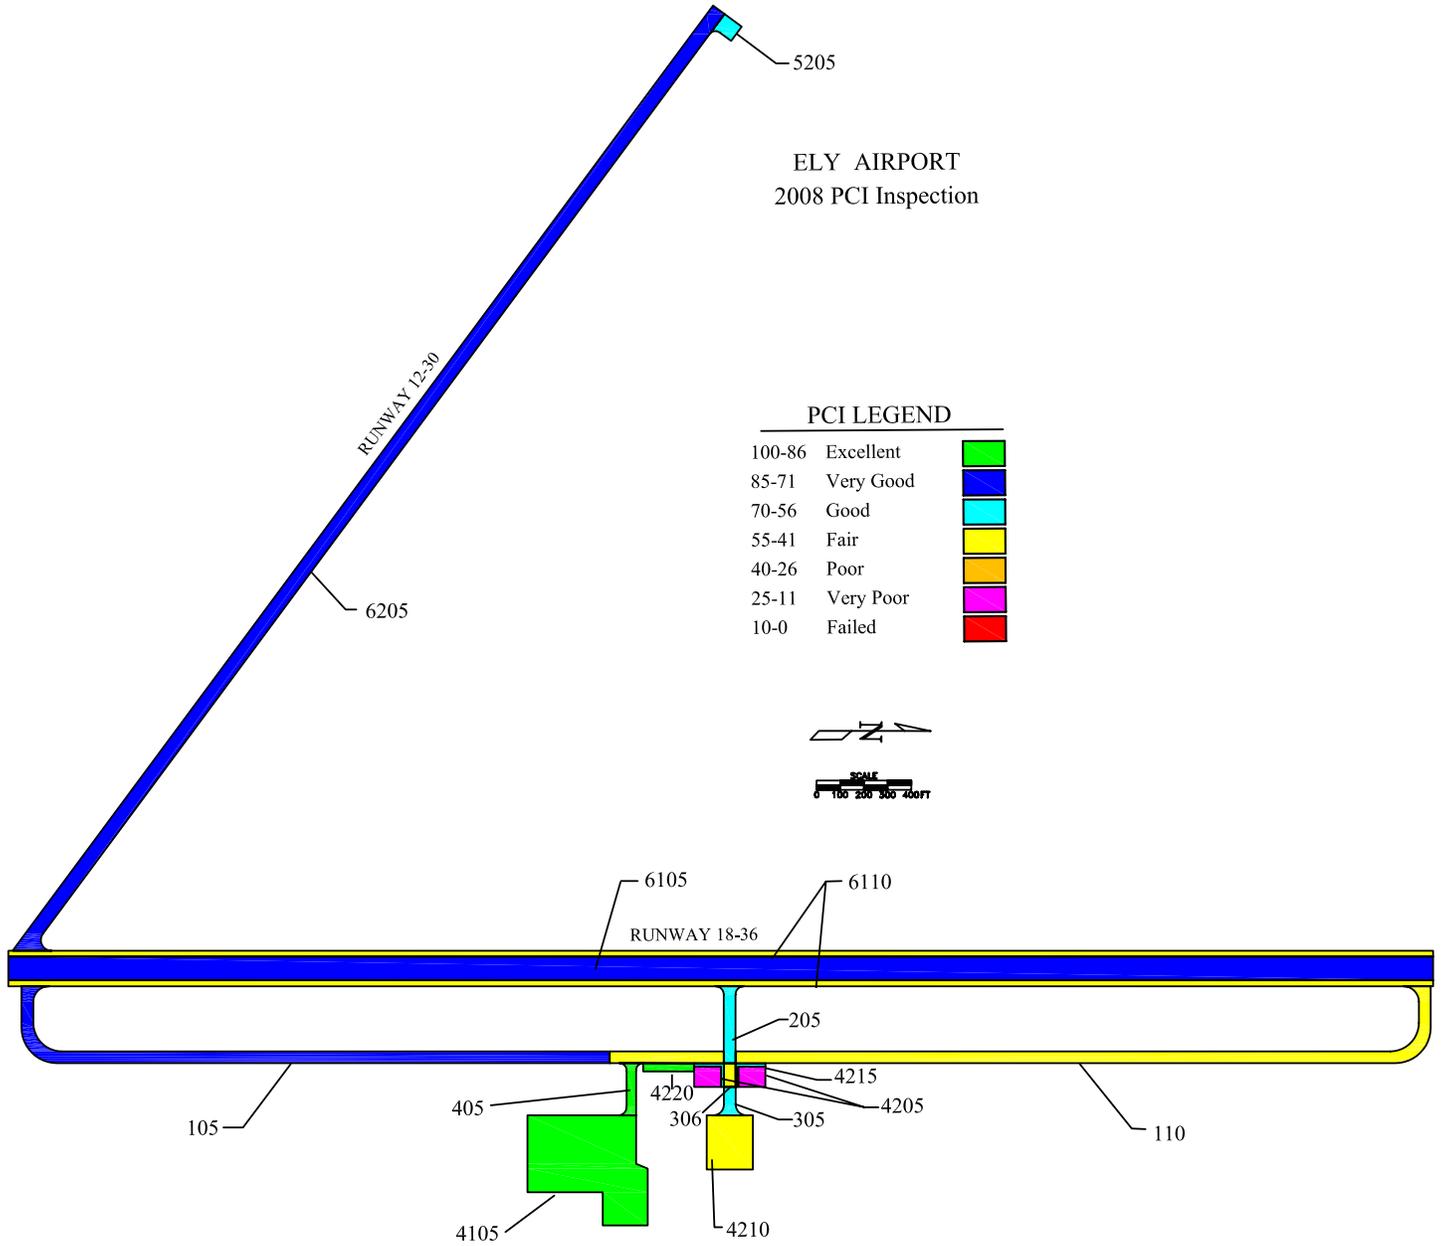
The average projected Pavement Condition Index (PCI) for all of the airfield pavements was **69**. The runways had an average projected PCI of **70** and were above the desired minimum service level (MSL) of **65**.

PCI analysis identified approximately **\$180,000** in pavement maintenance needs, such as patching and crack sealing, that could be completed immediately.
