EAST PORTAL
STABILITY STUDY

CARLIN CANYON TUNNELS

ELKO CO. NEV.

NOVEMBER 1973

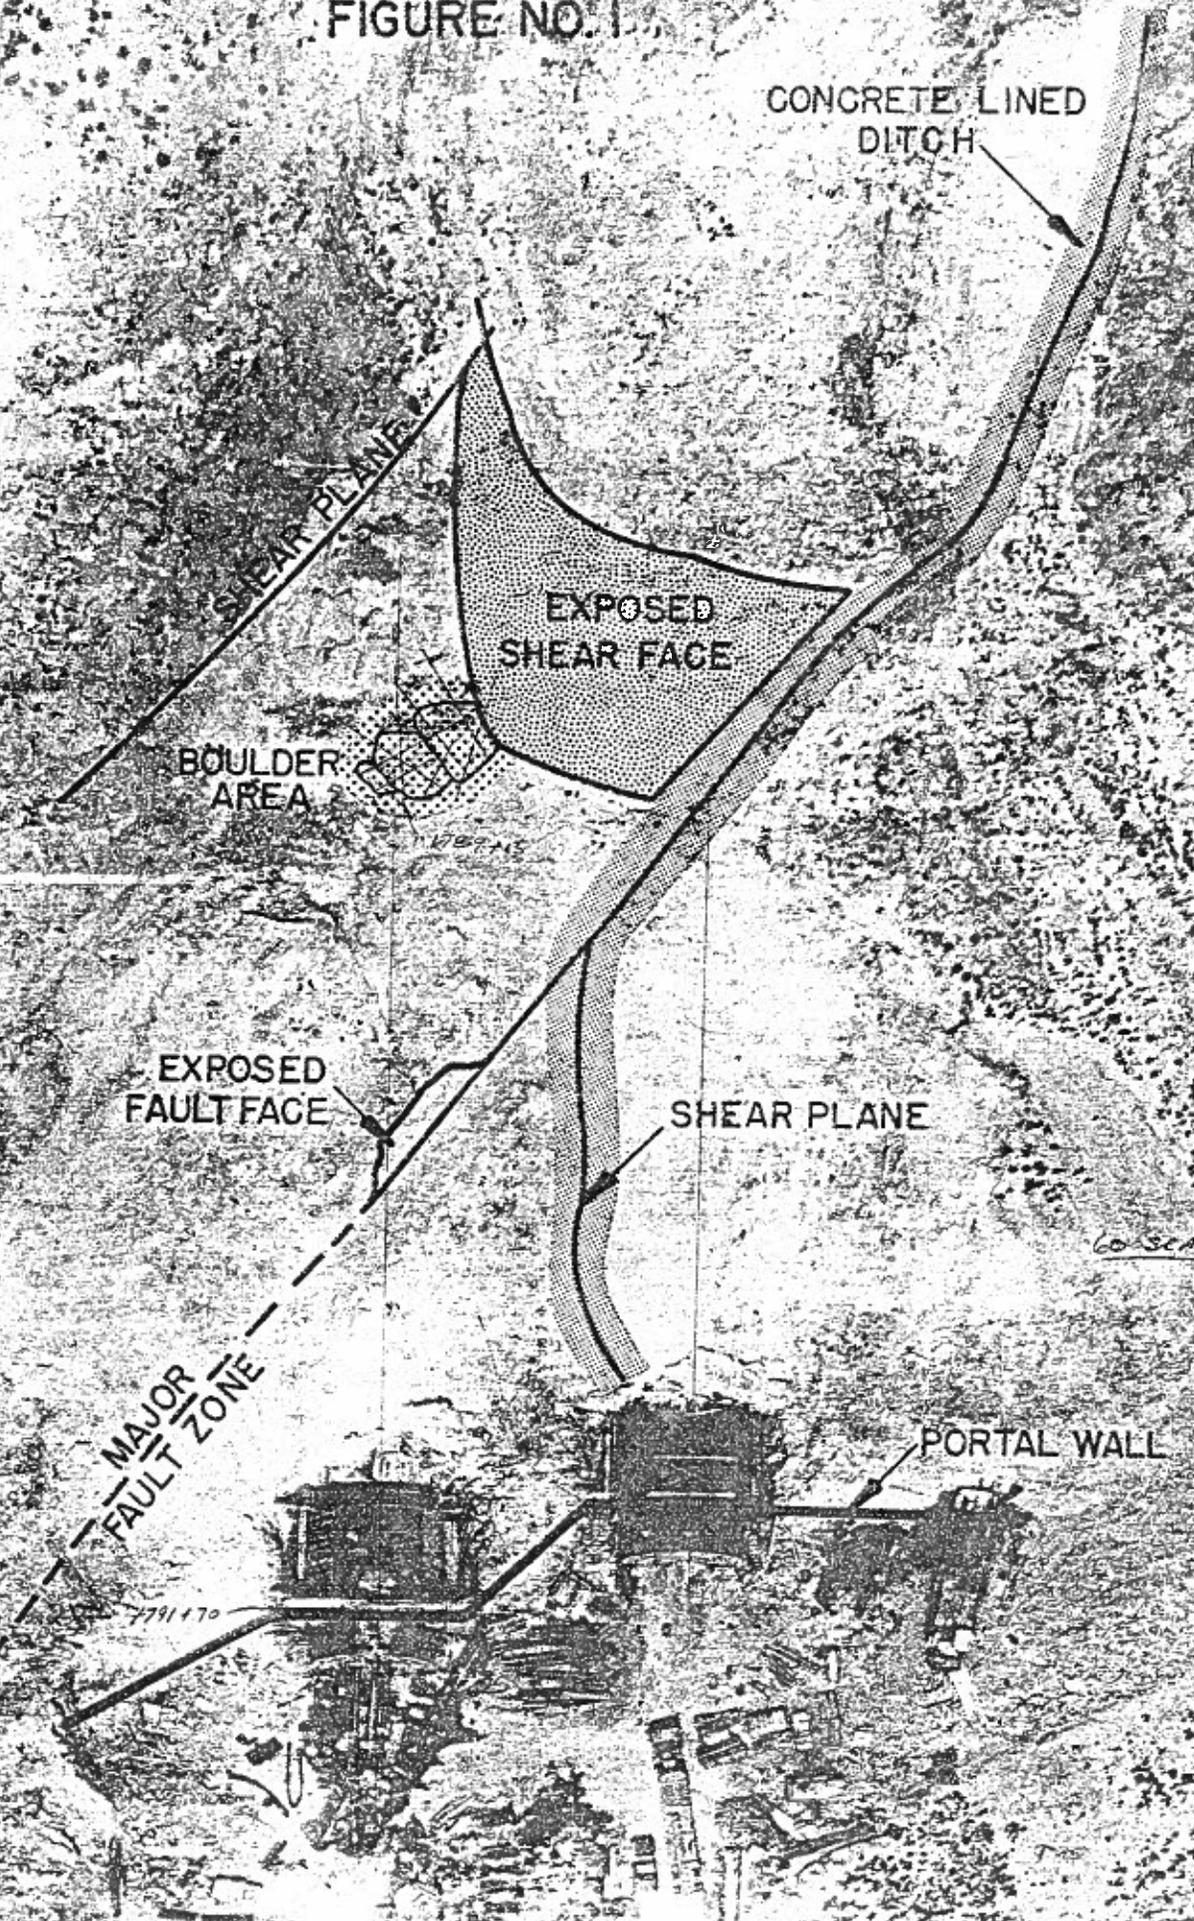
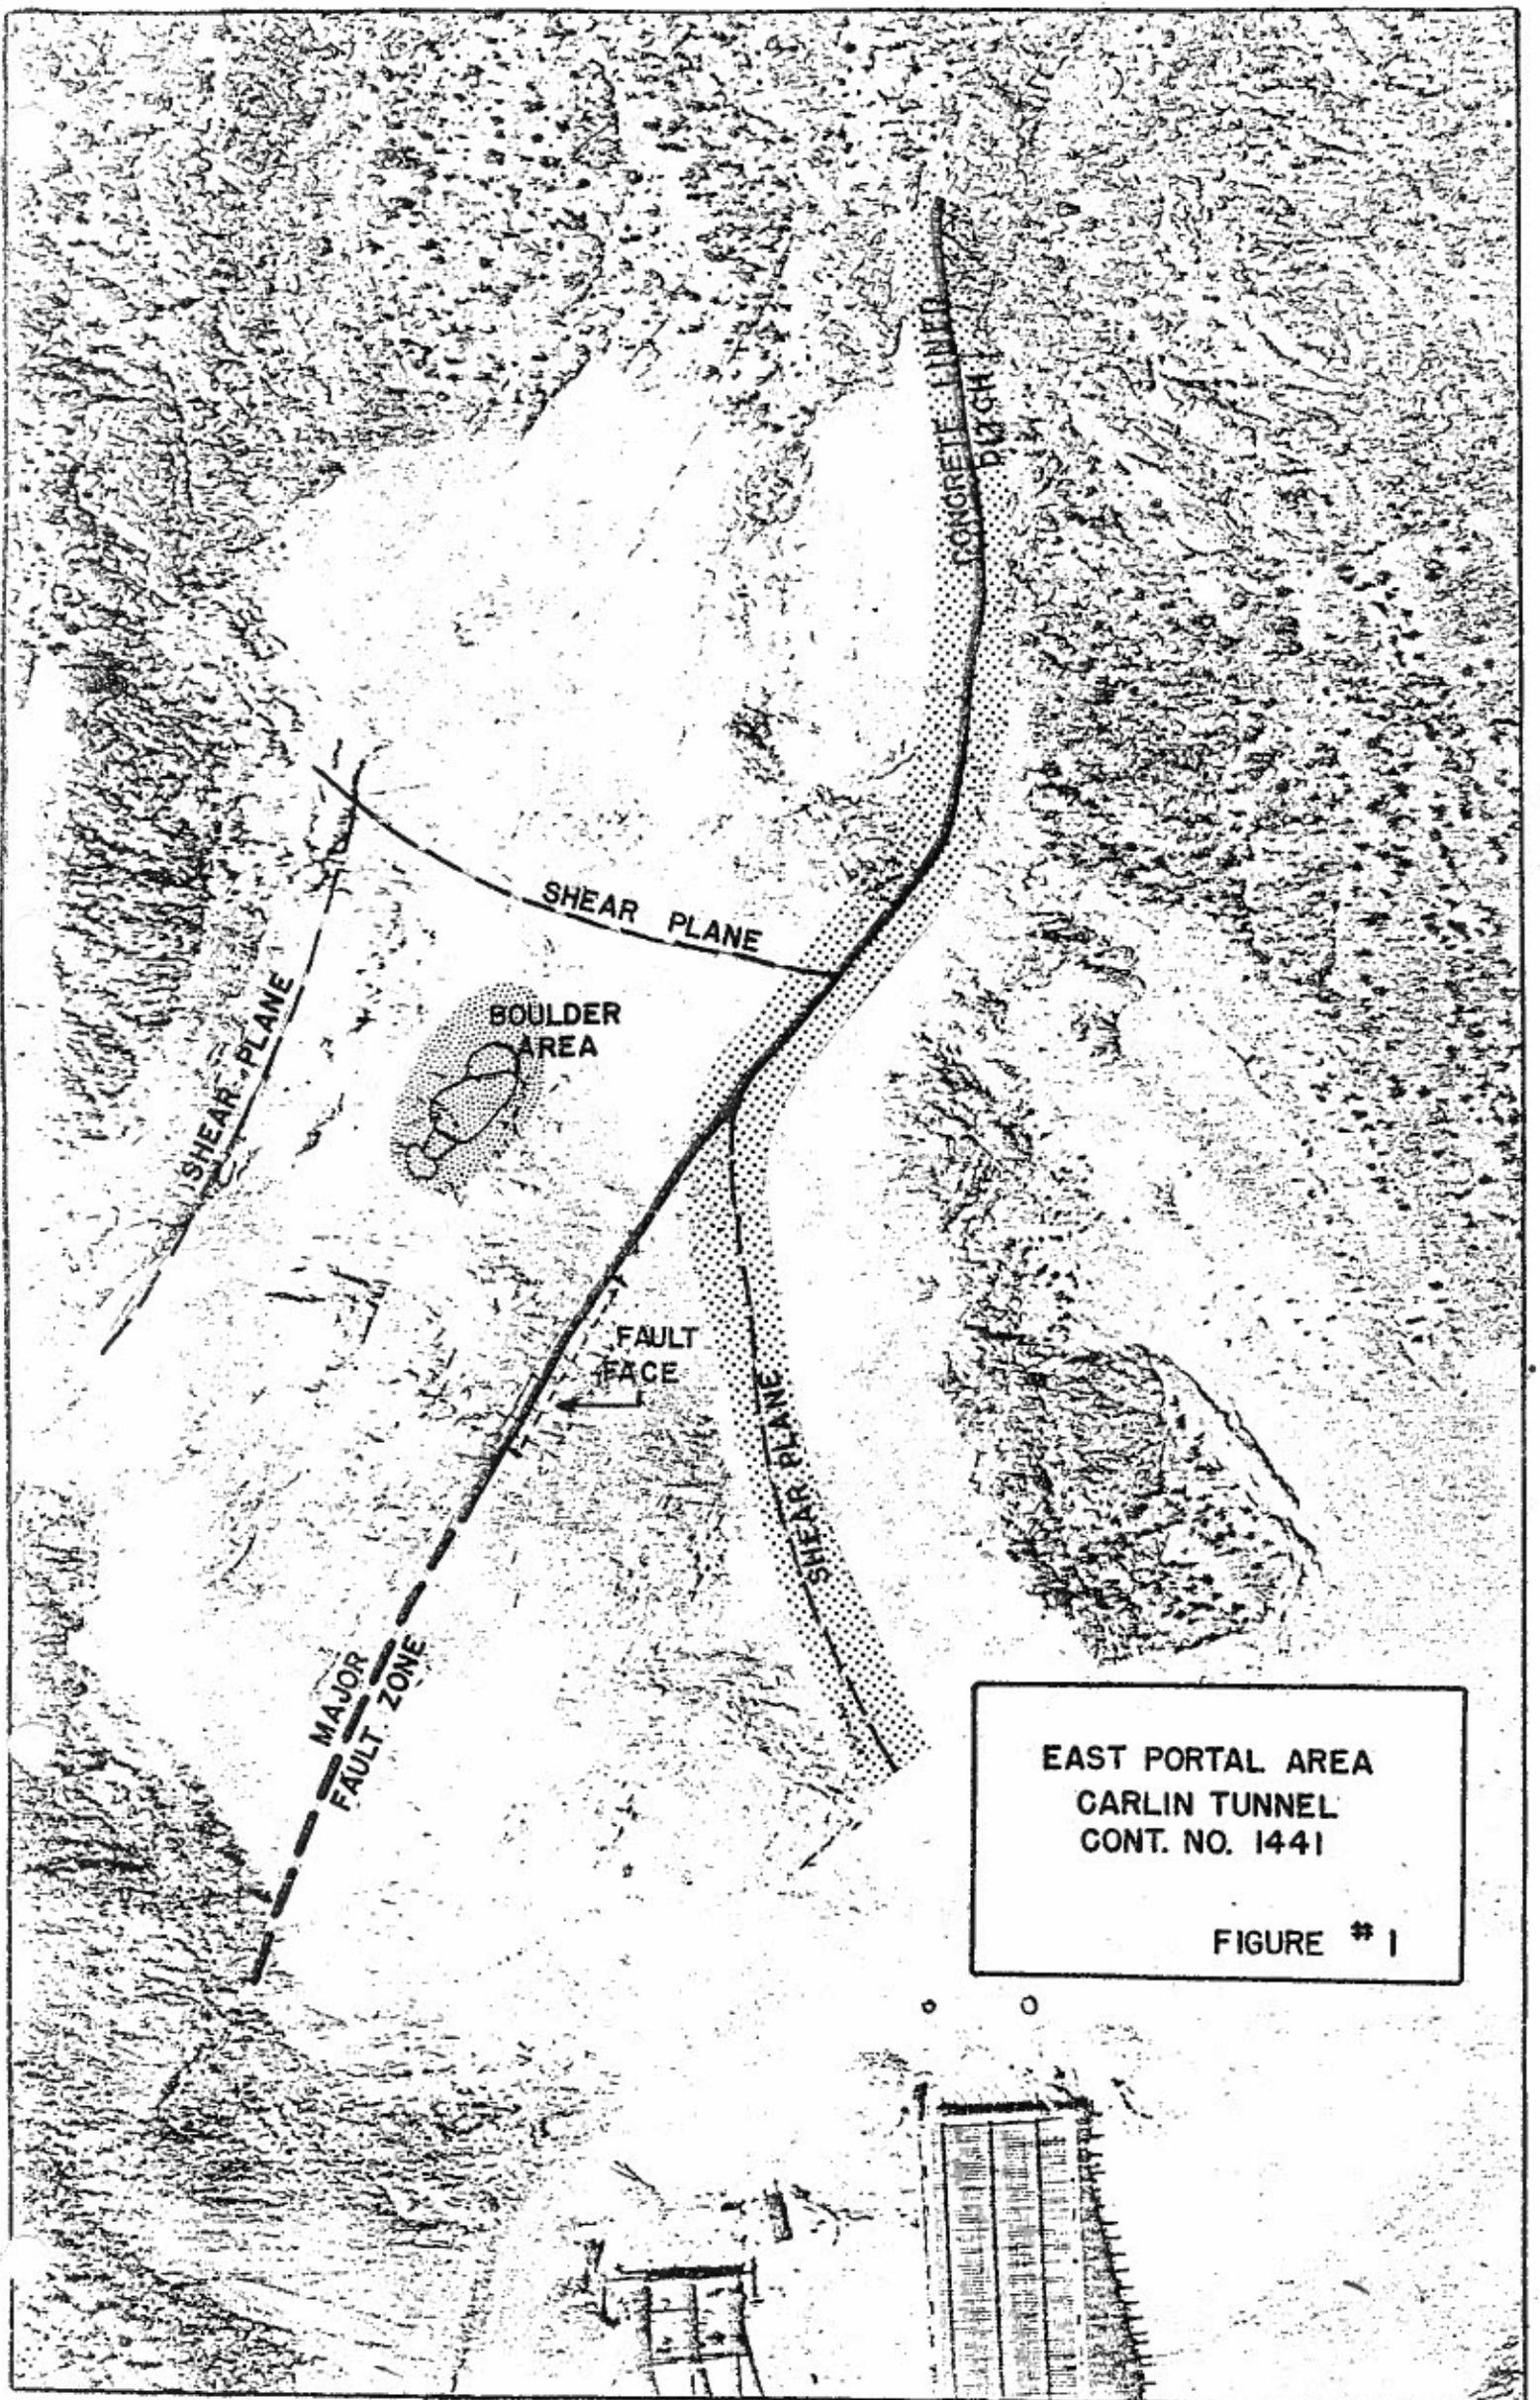
FIGURE NO. 1

The major fault trends N 15° - 20° W and dips 70° - 80° NE. This is apparently a bedding plane fault with dip and strike correlating quite closely to the dip and strike of the bedrock. Another smaller, steeply dipping shear zone, in some places less than 1/2" wide crosses the major fault approximately 100' west of the westbound centerline. About 140' behind the portal wall and approximately equidistant between the two bores, this plane intersects another shear zone along the bedding plane. The intersection of these three planes has produced a triangular area of potentially unstable material consisting of large "boulders" surrounded by highly sheared although essentially competent material. (See Figure 1.)

Second, higher up the face, some rock exposed on the bedding plane fault is fractured and appears to present a problem. However, close inspection of these fractures shows that they are filled with soil, thus indicating their existence over a long period of time.

Finally, higher on the face are the three large "boulders" that appear as if they could work loose and tumble to the portals. These could in reality be in-place bedrock and prove to be stable, but it is not known for sure.

3.4. The possible instability previously described as the "boulder" area could be corrected by the use of rock bolts. These bolts would tie the boulders together and also could be installed through the boulders and into the bedrock behind. Rock bolts up to 40 feet in length may be required to reach bedrock in this area.

4.5. Drainage above the portals should be such that no ponding can take place, and if any vertical fractures are discovered they should be filled with grout. Since the major fault zone is depressed in the upper area and acts as a drainage channel, as an extra precautionary measure to prevent water from entering this zone the depression could be cleaned and lined with concrete. (See Figure 1).

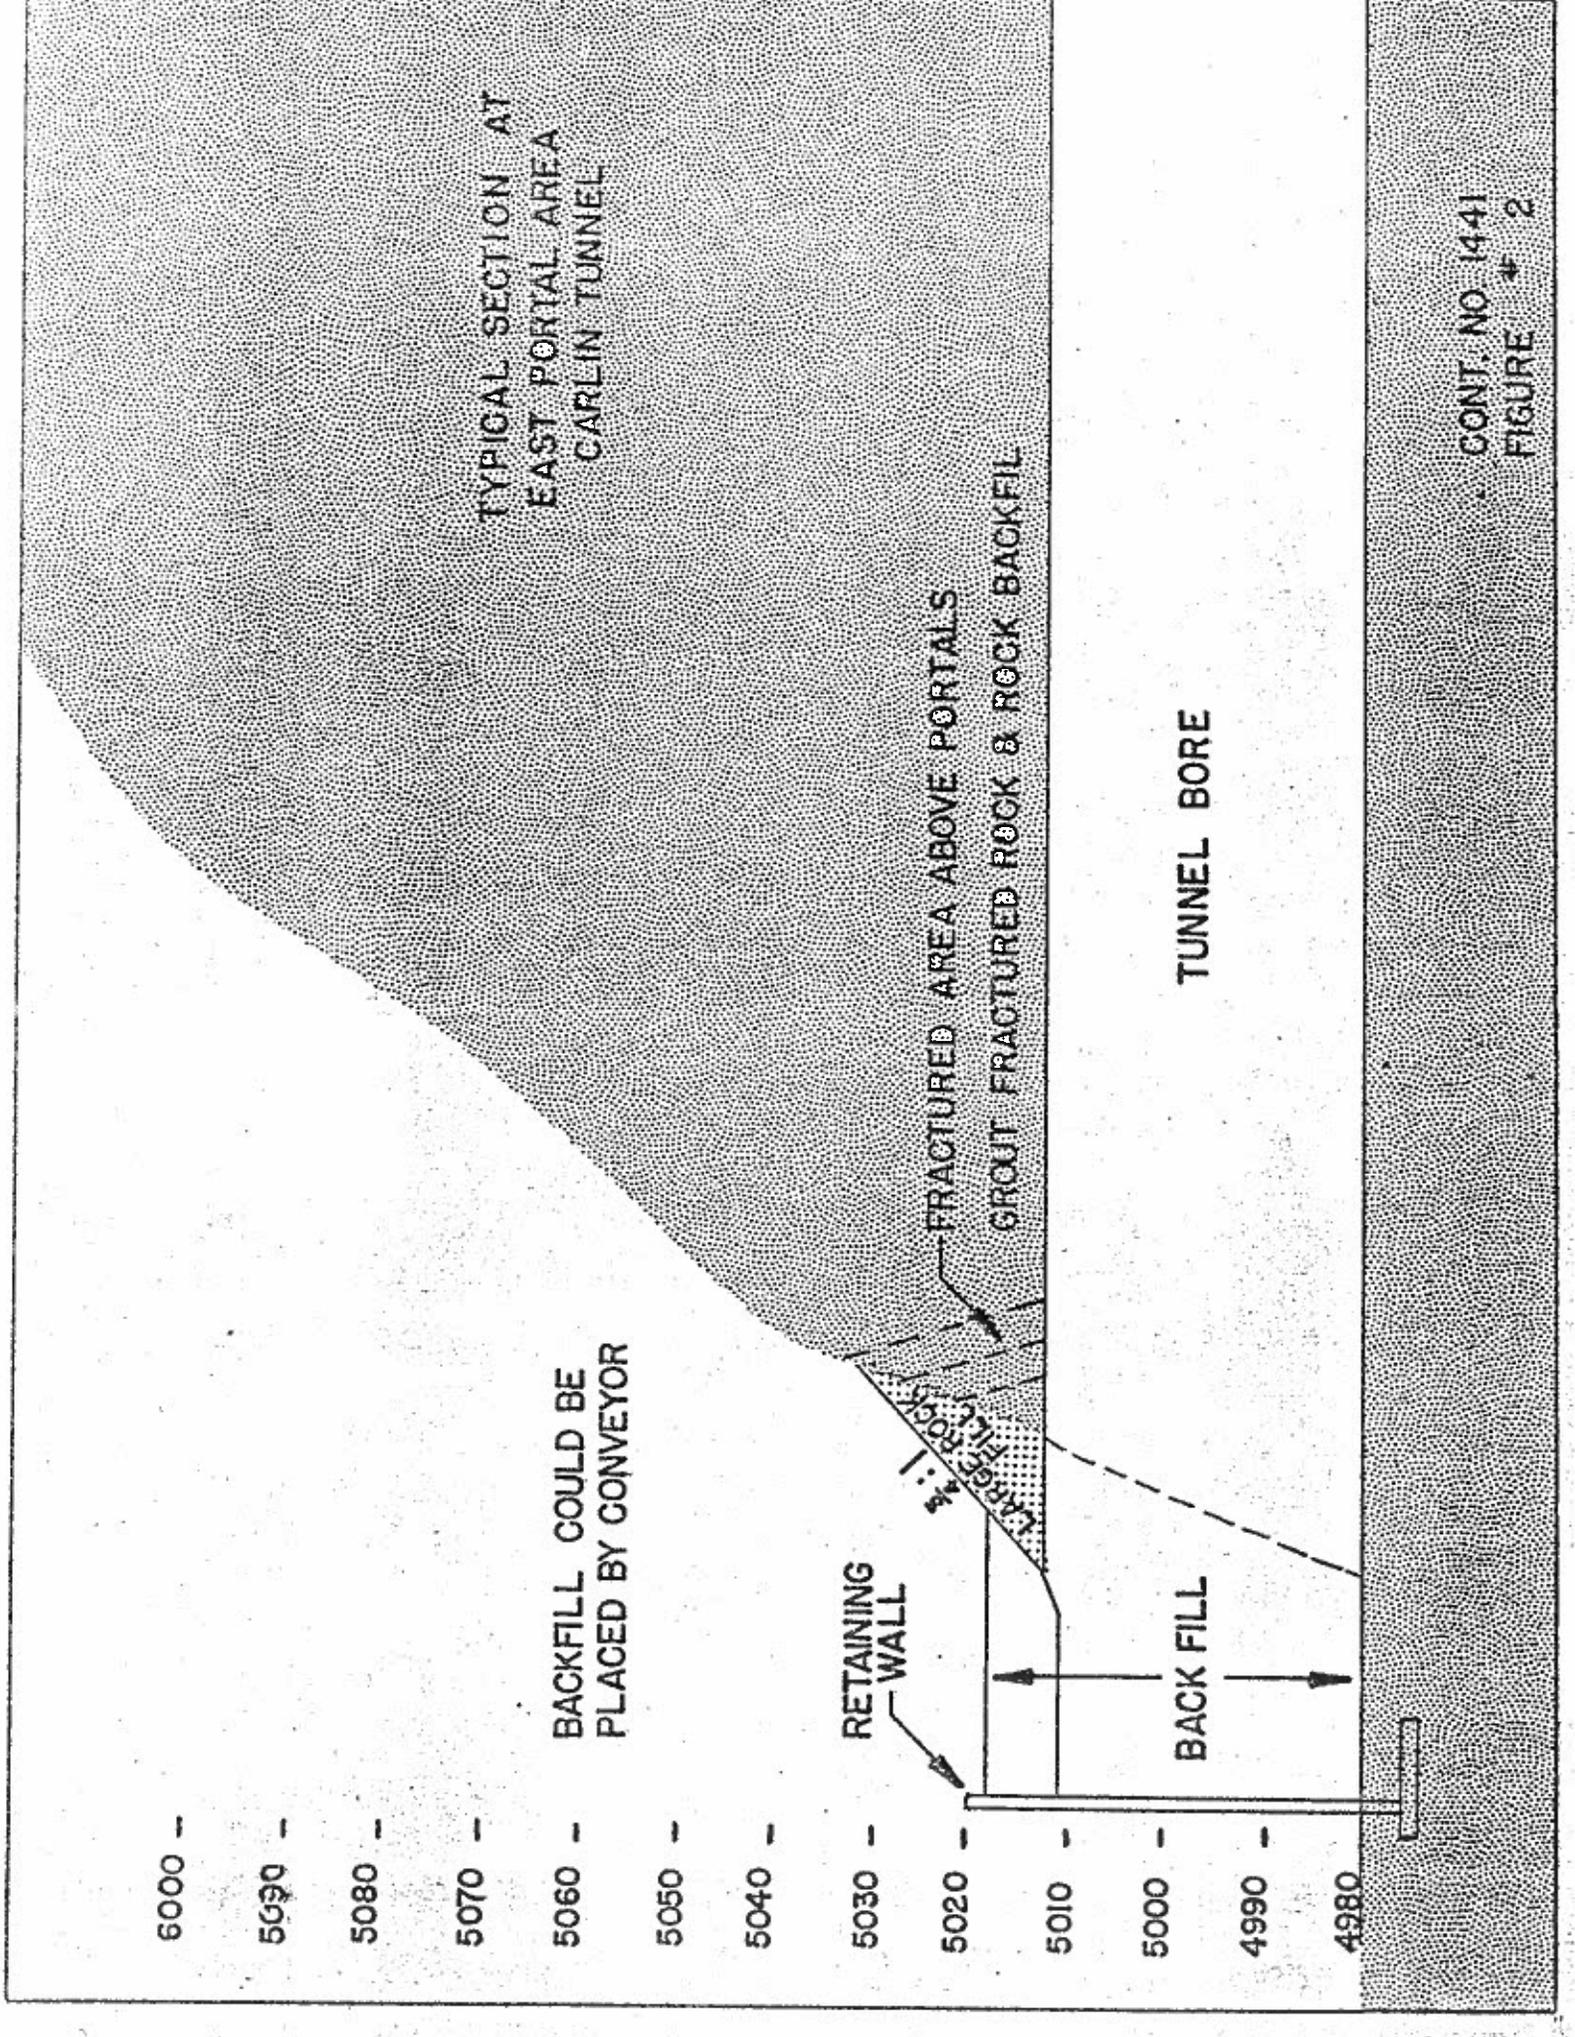
TYPICAL SECTION AT
EAST PORTAL AREA
CARLIN TUNNEL

First, a large rock mass above the portal wall and between the tunnel bores was apparently loosened by the final portal excavation blast. Mr. Cress, the Resident Engineer, stated that 5335 lbs. of explosive was utilized for this blast as compared to only 800 to 1500 lbs. for previous shots. This obvious over-shooting at a tunnel portal area, where maximum weathering and associated rock incompetence is legendary, indicates contractor inattention at best and outright incompetence at worst. This unnecessarily large shot undoubtedly loosened and fractured this rock mass.

FRACTURED AREA ABOVE PORTALS
GROUT FRACTURED ROCK & ROCK BACKFIL

A feasible solution to this possibly dangerous condition would be to place the portal wall backfill using a conveyor system. The backfill should be placed to the top of the portal wall, then large rock should be placed from the top of the wall at a 3/4 to 1 slope over the fractured area. (See Figure 2.) Grouting of the rock backfill and the fractured rock above the portals could then be accomplished without danger to the workmen.

BACKFILL COULD BE
PLACED BY CONVEYOR
