PANACA / LINCOLN COUNTY AIRPORT

Pavement Condition

LINCOLN COUNTY AIRPORT
2009 PCI Inspection

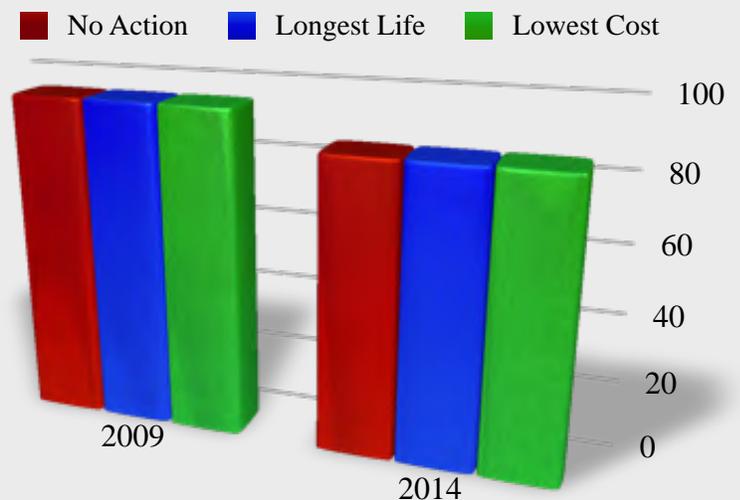
The average inspected Pavement Condition Index (PCI) for all of the airfield pavements was **95**. The runway had an average inspected PCI of **95** and was above the desired minimum service level (MSL) of **60**.
